PROJECT REPORT · SEPTEMBER 2026

# Chiúre Borehole Rehabilitation Project

Restoring safe, reliable, year-round water for three communities in Chiúre: Namogelia, Marrere and Halaka, by rehabilitating six boreholes fitted with Afridev handpumps.

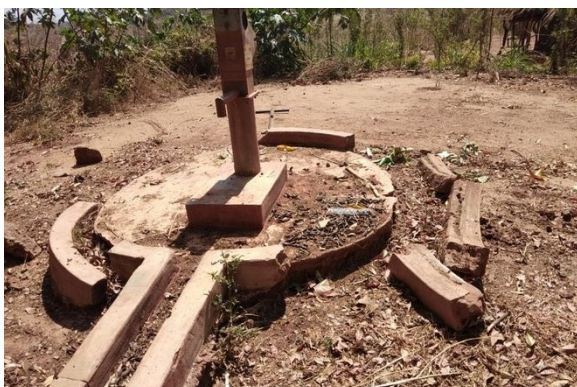
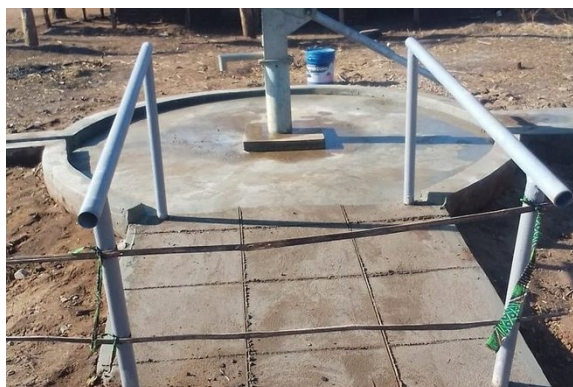
Pump seized or not working  
Cracked or broken apron  
Damaged drainage and soak-away  
Borehole unreliable or out of service  
Families using distant or unsafe water

Before and after: a borehole with a cracked apron and failed pump (left), restored to full working order with a rebuilt, accessible surround (right).

Afridev pump repaired and working  
Concrete apron restored  
Drainage and soak-away rebuilt  
Flushed, disinfected and tested  
Water point back in everyday use

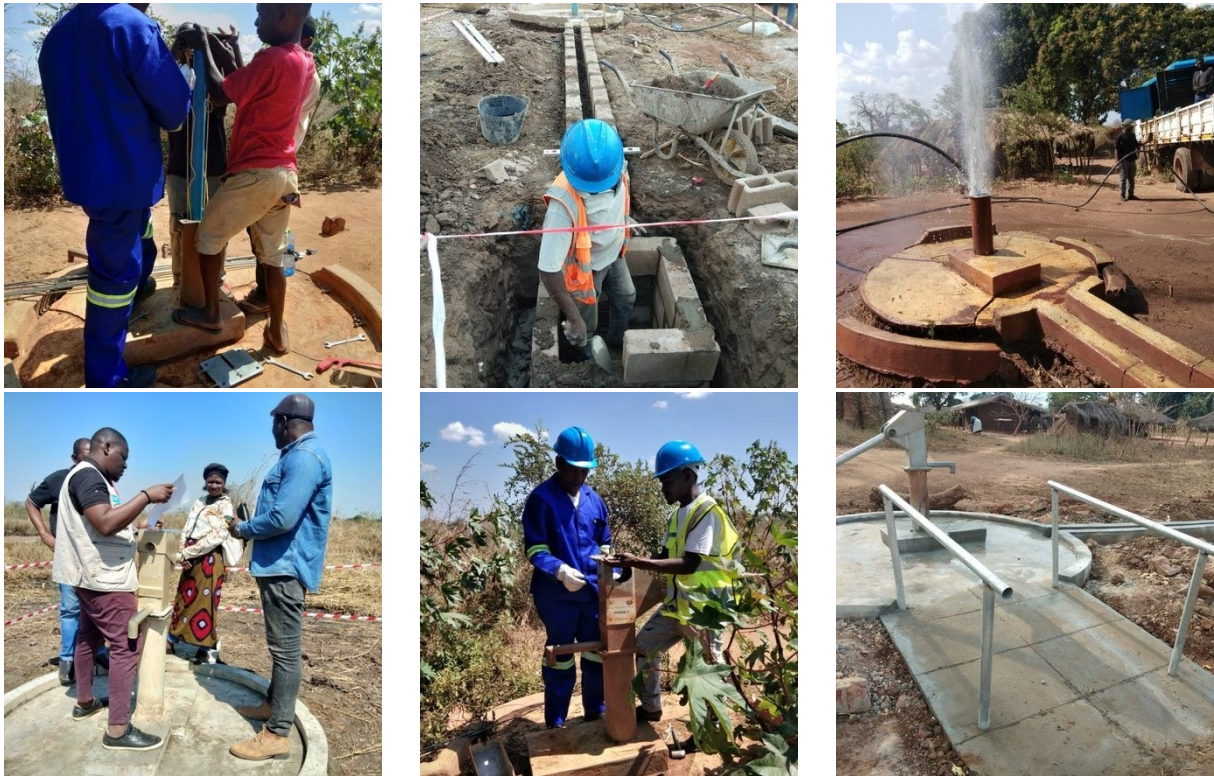
Top row: replacing worn Afridev pump components, rebuilding the drainage and headworks, and flushing the borehole until the water runs clean. Bottom row: inspecting and testing the pump, operating it with the community, and the finished, accessible water point.

- 1 Assess.** Inspect the borehole and pump to confirm the fault and the full scope of work needed.
- 2 Repair the pump.** Replace worn Afridev components such as rods, seals and cylinder parts.
- 3 Rebuild the headworks.** Rebuild the concrete apron, drainage channel and soak-away that keep dirty water away from the well.
- 4 Flush, disinfect & test.** Develop the borehole until the water runs clean, disinfect it, and check the pump draws reliably.
- 5 Hand over.** Return the borehole to community use, maintained with basic tools and local spares.
